SWF Home Inspections

SUMMARY REPORT

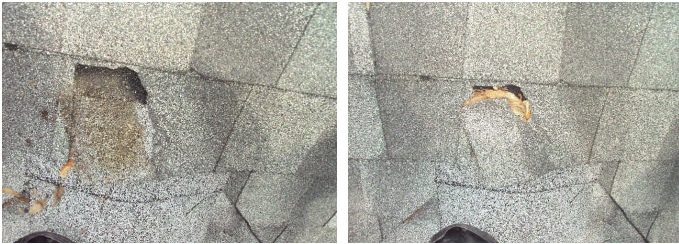
- There is a missing tab that should be repaired

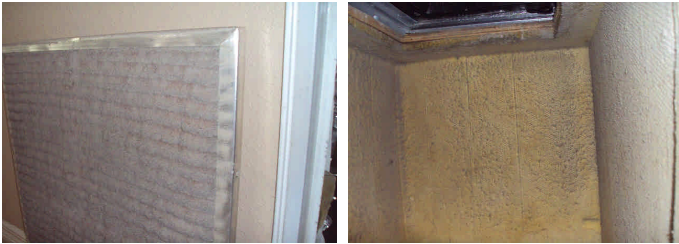
- The filter is dirty and should be changed soon and every two or three months. If filters are not changed regularly, the evaporator coil and the ducts can become contaminated, and can be expensive to clean.

The filter is dirty and should be changed - *Continued*
