SWF Home Inspections

CONFIDENTIAL INSPECTION REPORT

Report File: Sample report

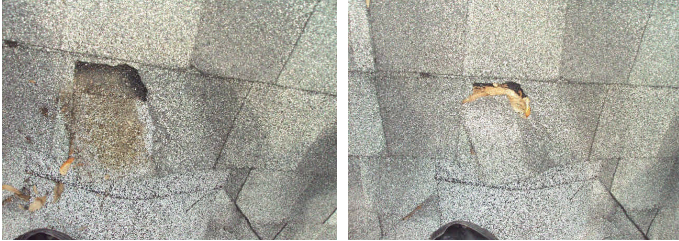
Components and Conditions Needing Service

There is a missing tab that should be repaired

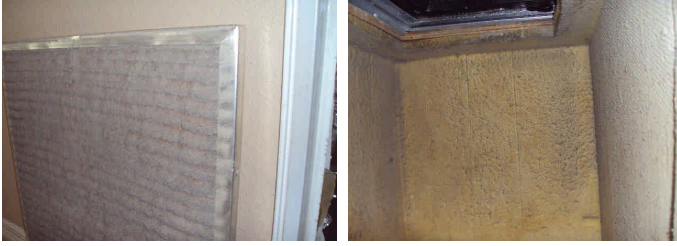
Components and Conditions Needing Service

The filter is dirty and should be changed soon and every two or three months. If filters are not changed regularly, the evaporator coil and the ducts can become contaminated, and can be expensive to clean.
